NATIONAL TRANSPORTATION SAFETY BOARD

AIRCRAFT ACCIDENT REPORT

COLLISION WITH TREES ON FINAL APPROACH
AMERICAN AIRLINES FLIGHT 1572
McDONNELL DOUGLAS MD-83, N566AA
EAST GRANBY, CONNECTICUT
NOVEMBER 12, 1995

**Adopted: November 13, 1996
Notation 6638B**

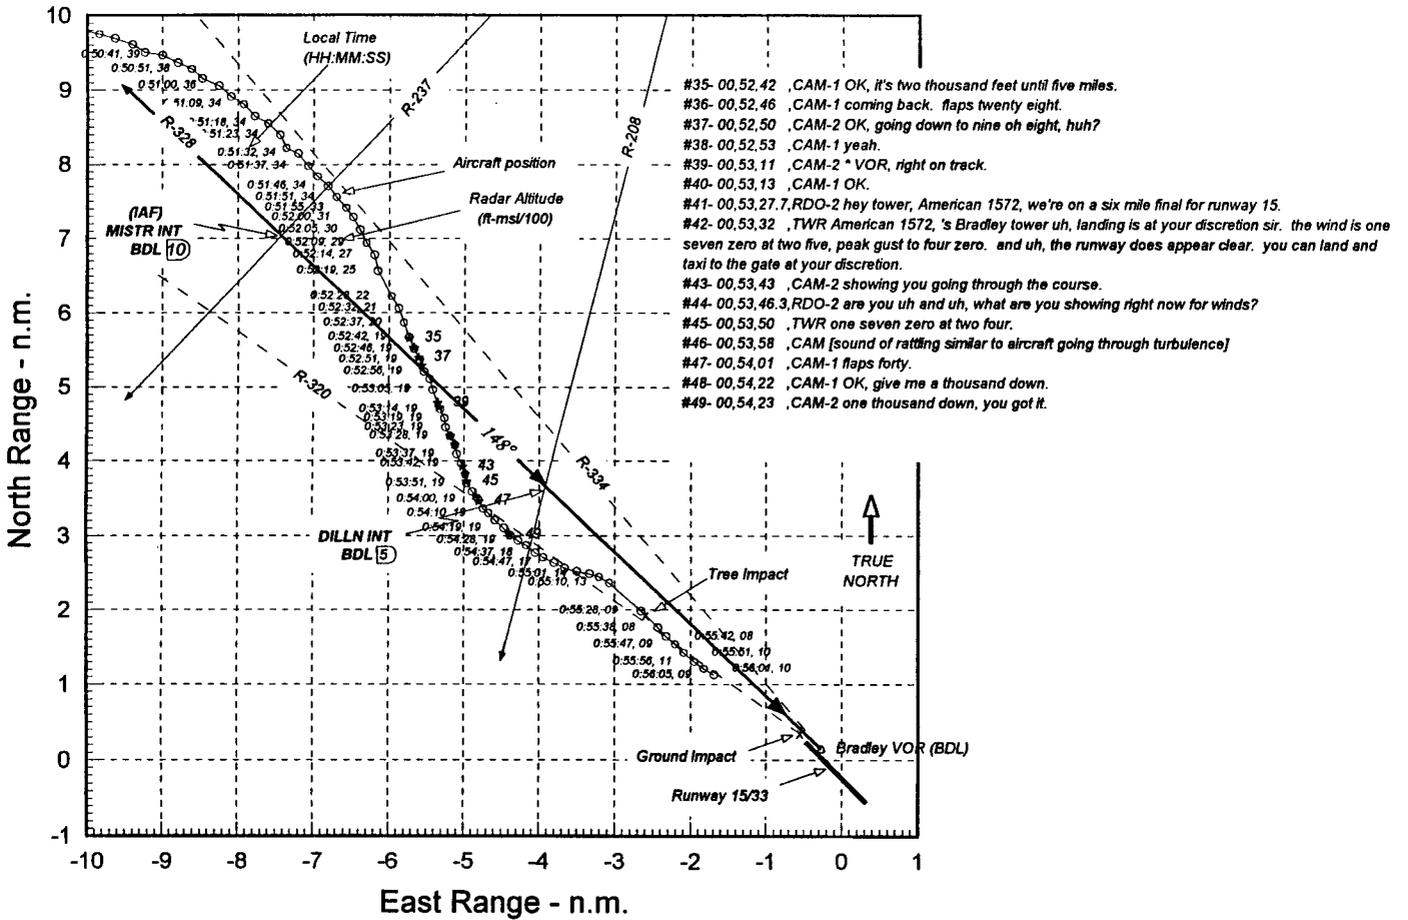
Figure 2a.—Plan view of the approach.

¹¹Investigators determined that the first impact point was with trees on the top of a ridge line approximately 2.54 nautical miles northwest of the approach end of runway 15.

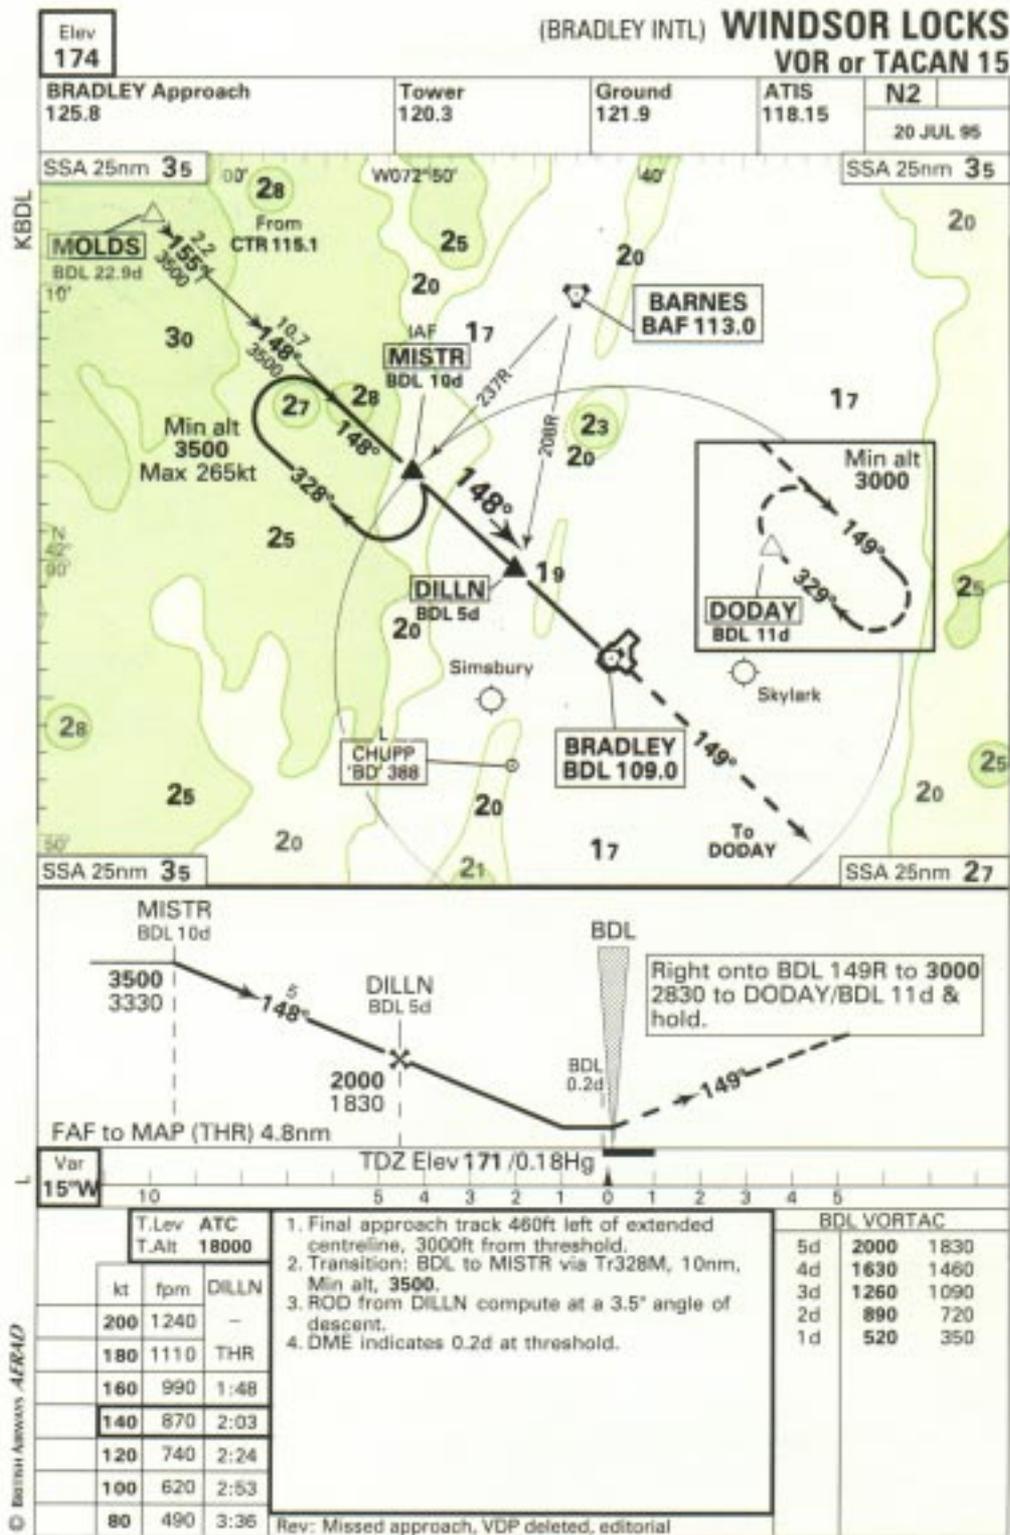
Figure 4.--BDL approach plate used by British Airways.

The single 819-foot obstacle depicted on the final approach course of most BDL runway 15 VOR approach plates could lead flightcrews to believe that there was one discrete obstacle, and that it was the only dangerous point on the final approach (see Figure 1). However, the Safety Board concludes that the entire ridge line is an obstacle, and that it and similar terrain close to other airports should be fully depicted on the appropriate approach charts. As an example, see Figure 4, the BDL approach plate used by British Airways. The Safety Board continues to believe, as reflected in Safety Recommendation A-96-102, following the accident near Buga, Colombia, that the FAA should require that all approach and navigation charts graphically present terrain information.
