NATIONAL TRANSPORTATION SAFETY BOARD

AIRCRAFT ACCIDENT REPORT

COLLISION WITH TREES ON FINAL APPROACH
AMERICAN AIRLINES FLIGHT 1572
McDONNELL DOUGLAS MD-83, N566AA
EAST GRANBY, CONNECTICUT
NOVEMBER 12, 1995

**Adopted: November 13, 1996
Notation 6638B**

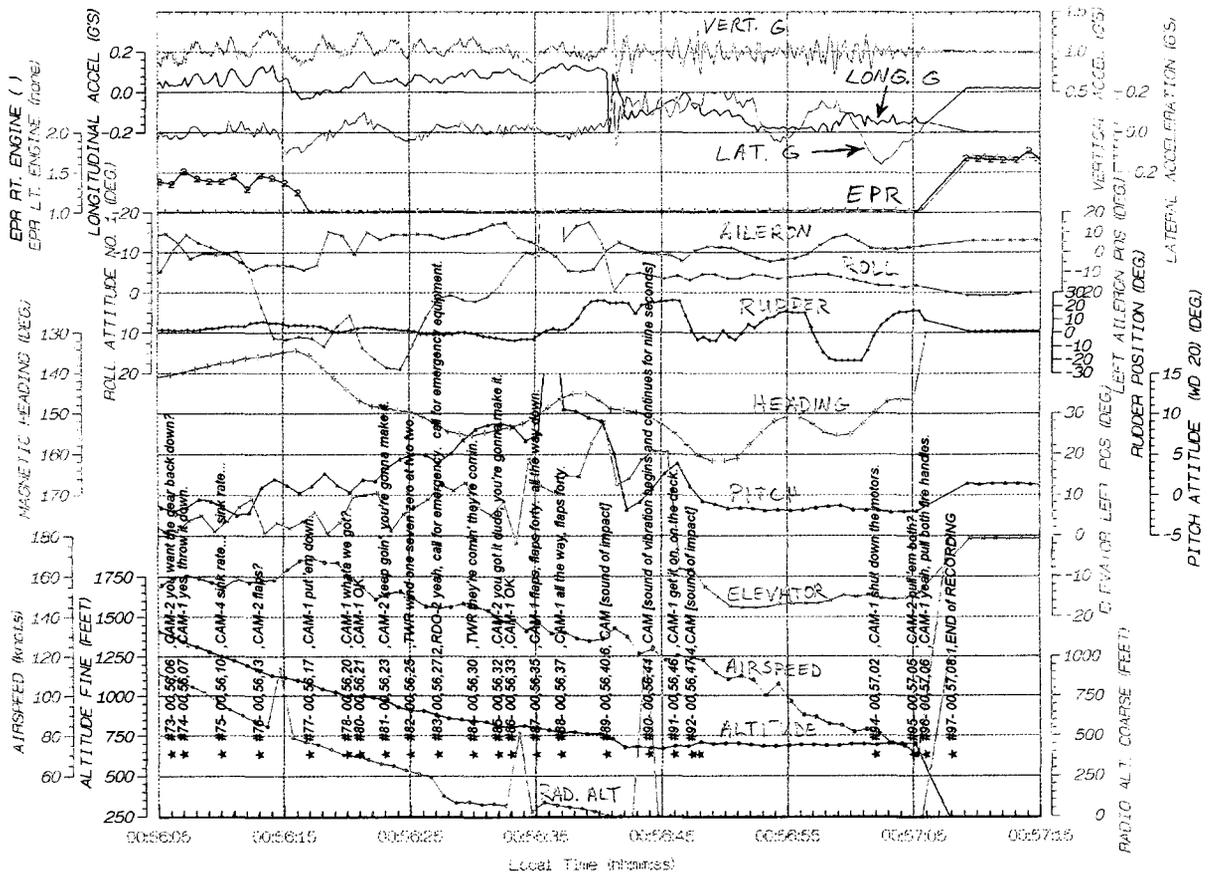
Figure 3b.--FDR plots and CVR comments.

The flight recorder tape was found undamaged with no evidence of excessive wear. The airplane was also equipped with a Fairchild model A-100A cockpit voice recorder (CVR) (S/N 53395). See Appendix B for a transcript of the CVR recording that lasts 31 minutes and 29 seconds. Figures 3a and 3b contain pertinent FDR parameters overlaid with pertinent flightcrew comments recorded on the CVR.
