CONTROLLED FLIGHT INTO STALL (CFIS): FUNCTIONAL COMPLEXITY FAILURES AND AUTOMATION SURPRISES

Lance Sherry, George Mason University, Fairfax, Virginia

Robert Mauro, University of Oregon, Eugene, Oregon

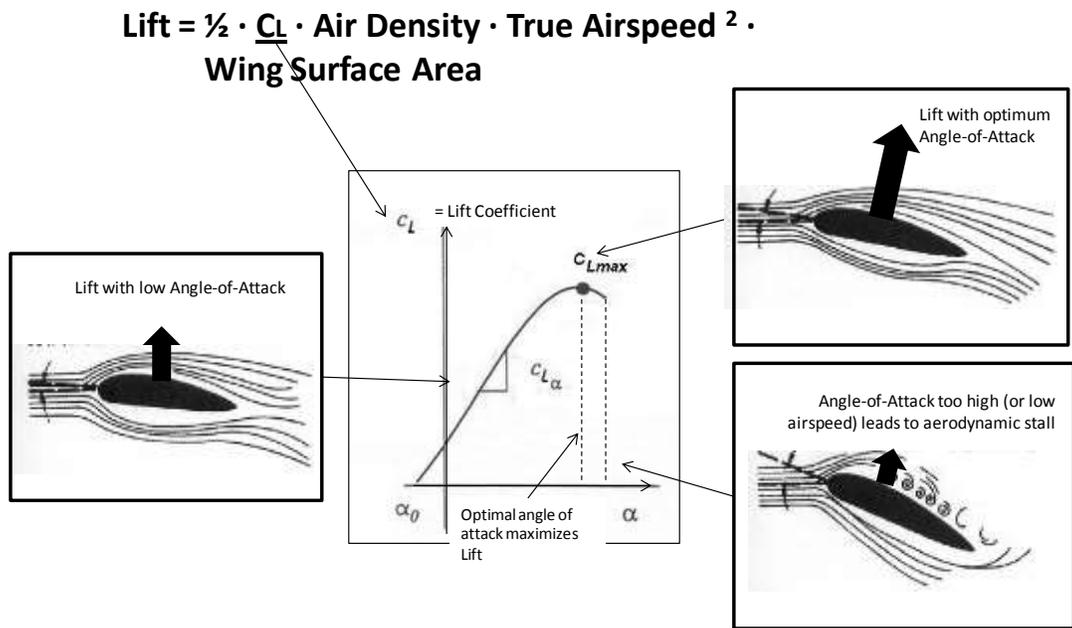
Figure 1: An airfoil generates a Lift force when the airflow over the wing exceeds a minimum airspeed, and when the airfoil angle with respect to the oncoming flow (known as angle-of-attack) is below a maximum allowable angle. The Lift force is proportional to the Lift Coefficient (C_L) that increases with Angle-of-Attack up to a maximum, at which point the airfoil experiences aerodynamic stall.

The fundamental phenomenon that enables heavier-than-air flight is that the airflow over an airfoil pushed through the air will generate a Lift force sufficient to raise the airfoil and an additional attached structure (see Figure 1). The properties of the Lift force require a minimum airspeed and cannot exceed a maximum angle-of-attack (i.e. the angle between the airfoil and the oncoming air flow). In the absence of sufficient airflow over the wings, or with too high an angle-of-attack, the airfoil will abruptly cease generating Lift. This condition is known as an *aerodynamic stall*.

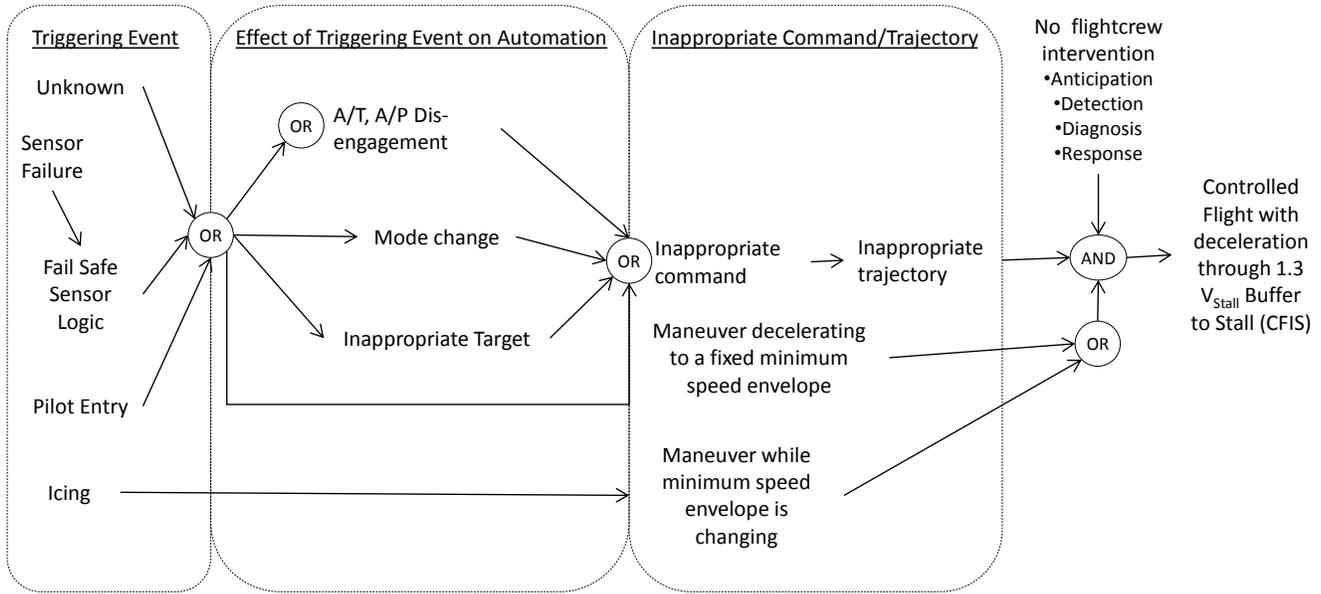
Figure 3: Summary of the scenarios leading to CFIS. A triggering event (e.g. sensor failure or pilot entry) affects the automation engagement status, mode, or target. These changes result in a pitch or thrust command inappropriate for the current operation. When the aircraft is decelerating to 1.3V_{Stall} (or the stall speed changes) due to an inappropriate command, the flight crew is unable to intervene in a timely manner.

All 19 accidents and incidents can be described by the sequence of events presented in Figure 3. The sequence starts with a *triggering event* (e.g. sensor failure) that has an *effect on the automation* (e.g.

mode change). This leads to an *inappropriate command* for pitch or thrust. The inappropriate command occurs while the aircraft is experiencing a relative *deceleration* to the minimum safe operating speed. The relative deceleration is the result of either the aircraft decelerating to a fixed minimum safe operating speed or a change in the minimum safe operating speed (i.e. ice). Finally, the flight crew *does not intervene* to arrest the deceleration through the minimum safe operating speed for controlled flight into a stall.
